East Yellow Creek
Recreational Use Attainability Analysis

July 2005

Prepared by:
MEC WATER RESOURCES, INC.
1000 North College Avenue, Suite 4
Columbia, Missouri 65201

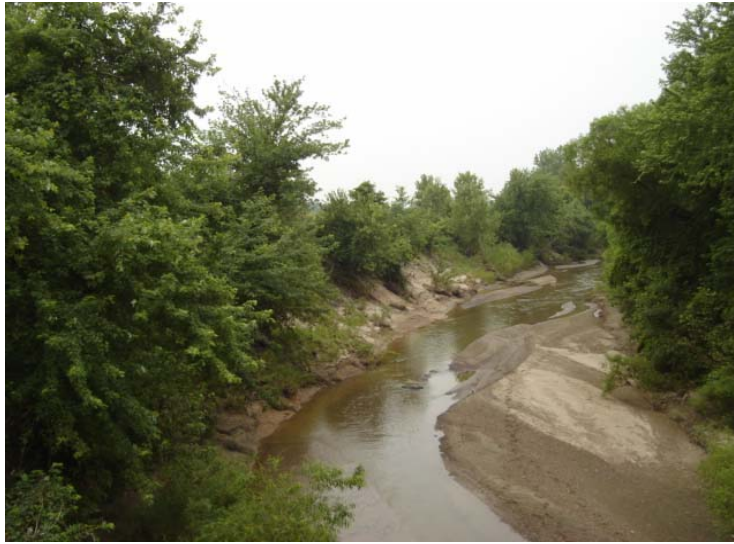
Figure 2. East Yellow Creek Site 1 Downstream View

The landscape near the Julep Road bridge crossing is mostly row crop with some lightly forested areas. The banks are steeply sloping and are mostly covered with sand and some grass and small shrubs (Figure 2). Riparian areas not wide and are composed of trees and shrubs. Channel substrate is predominately sand with minimal gravel present.

Mean depth along a 1200 ft. assessment reach was 0.32 ft as determined from 10 transects (Appendix B). The maximum depth observed at this location was .8 feet. MEC staff measured streamflow as 8.18 cfs at the bridge.

MEC staff did not observe any direct or indirect evidence of WBCR at Site 1. MEC staff did observe trash in the form of old tires and boxes that were likely dumped from the bridge (Figure 3). Additionally, spent shotgun shells and broken clay targets were observed on the stream bank.

MEC staff believe that WBCR is neither an existing or an attainable use at this site based on limited access to the stream imposed by steep slopes, absence of observed WBCR uses, and low flow shallow conditions.

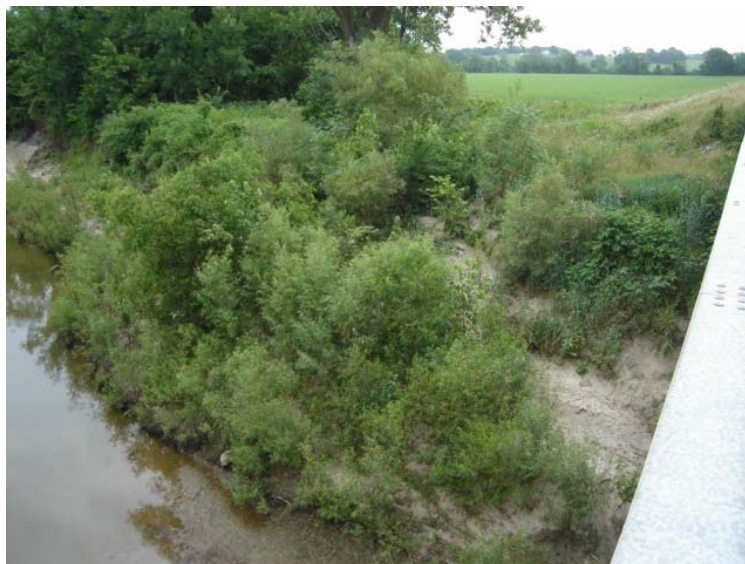
Figure 4. East Yellow Creek Site 2 Right Bank

The stream banks near the road are steeply sloping and are covered with low-growing brush and rocks (Figure 4). Riparian areas are vegetated by the upland deciduous forest complex and row crop agriculture. The stream channel was observed to be mostly sand with some cobble and gravel (Figure 5).

Mean depth along a 900 ft. assessment reach was 0.38 ft. as determined from 11 transects (Appendix B). The maximum depth observed at this location was .91 ft. in a small pool downstream of the road access. Flow was measured as 8.55 cfs.

MEC staff concludes that WBCR is neither an existing or an attainable use at this site based on absence of observed recreational uses, low flow shallow conditions and difficult stream access imposed by steeply sloping banks.

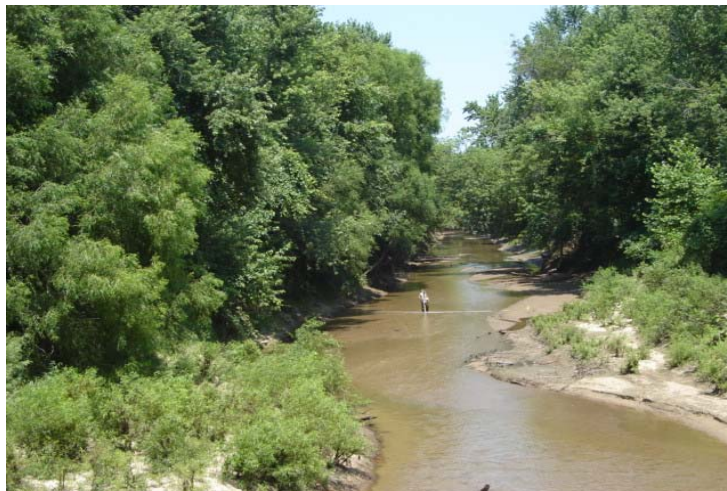
Figure 6. East Yellow Creek Site 3 Downstream View

The riparian area is generally wider at Site 3 than that at Sites 1 or 2 and consists of larger trees, thick brush, and some grassy areas (Figure 6). The stream banks at Site 3 are somewhat steep and covered with rocks, brush, and downed trees (Figure 7). Stream substrate consisted of mostly sand with some mud and clay.

Mean depth along a 700 ft. assessment reach was 0.57 feet as determined from 11 transects (Appendix B). The maximum depth observed at this location was 2.74 feet in a pool downstream of the road access. Measured streamflow was 11.21 cfs.

MEC staff concludes that WBCR is neither an existing nor an attainable use at this site based on the low flow shallow conditions and the lack of observed WBCR uses.

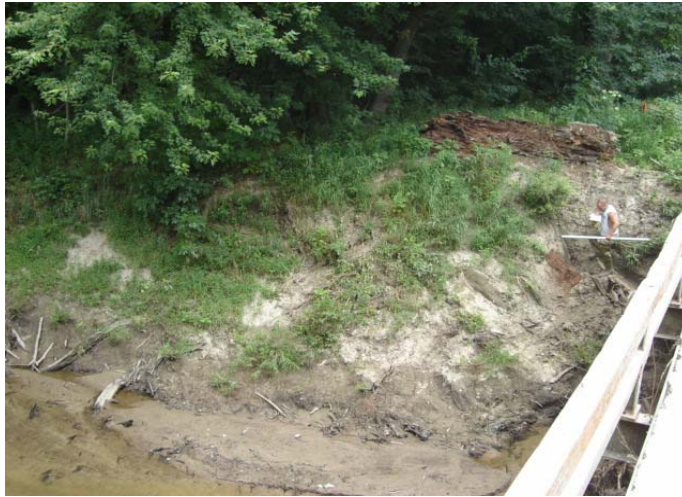
Figure 8. East Yellow Creek Site 4 Right Bank

The stream banks near the crossing at Road 208 are steeply sloping and lightly vegetated (Figure 8). Riparian areas are vegetated by upland deciduous forest and row crop agriculture. The stream channel was observed to be mostly sand with some cobble and gravel. A large pool was present downstream from the bridge and was likely due to the logjam that stretched across the stream beneath the bridge (Figures 9 and 10).

Mean depth along a 960 ft. assessment reach was 0.55 ft. as determined from 11 transects (Appendix B). The maximum depth observed at this location was 1.66 feet. Measured streamflow was 11.21 cfs.

MEC staff concludes that WBCR is neither an existing nor an attainable use at this site based on the low flow shallow conditions, steep slopes, and the lack of observed WBCR uses.
